# Documentation on past disasters, their impact, Measures taken, vulnerable areas in Assam.

## 1. Introduction

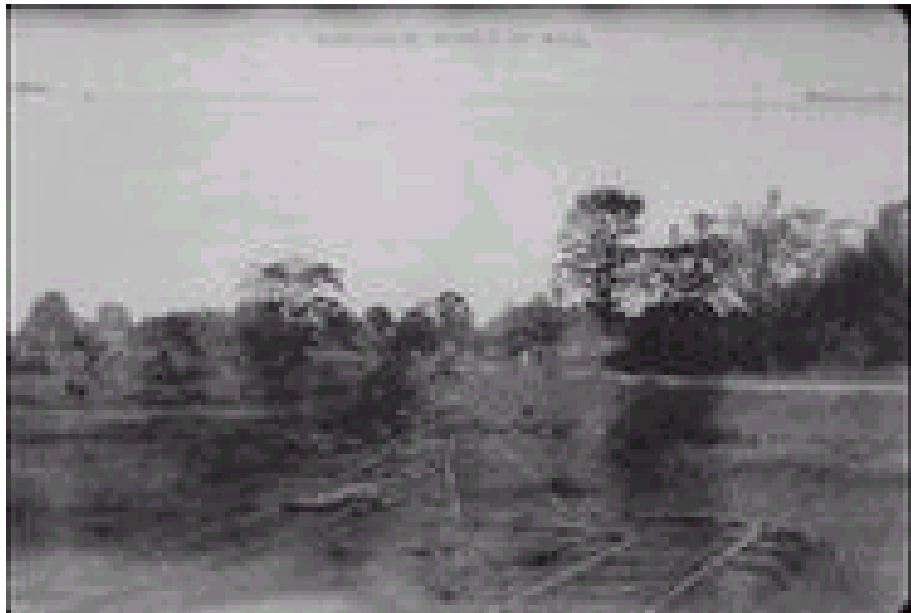
**Bent rails at Rangapara,  
Tezpur-Balipara Tramway**

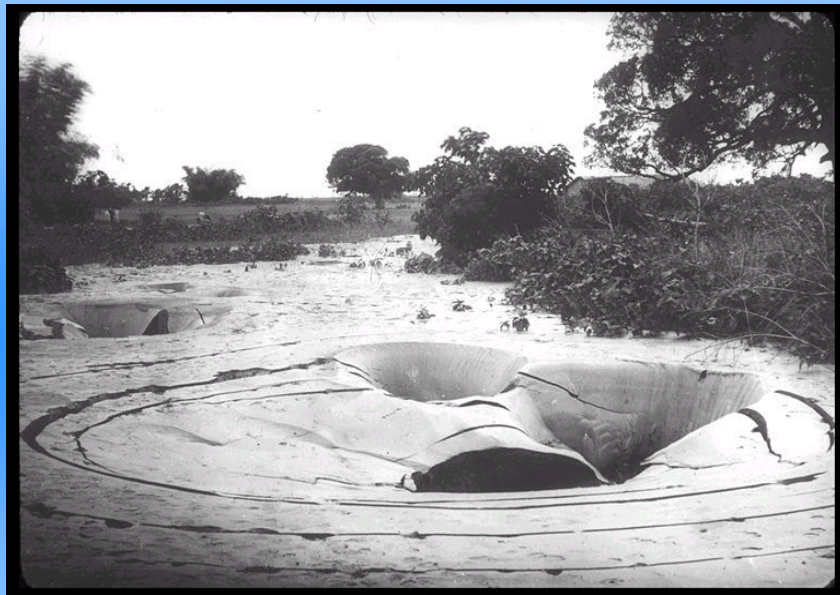
**SAND VENT AT ROWMARI, 12 JUNE, 1897**

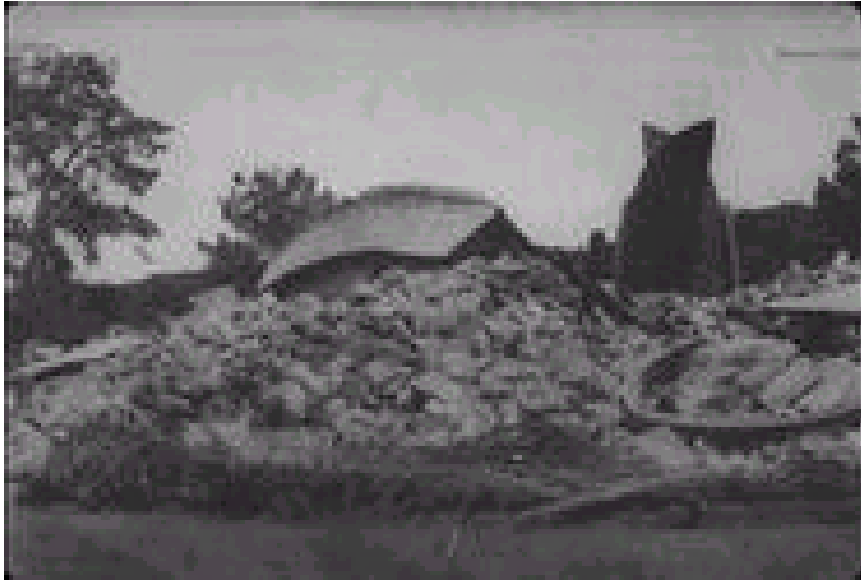
### **All Saints' Church, Shillong**

The earthquake caused great destruction to many towns in Assam and Meghalaya. Most often referred to is Shillong and Guwahati, where most of the structures like the Telegraph House, were demolished. For example, all stone works in the neighbourhood of Shillong, including most of the bridges, were absolutely leveled to the ground. The stone houses, and particularly the Churches, were reduced flat heaps of rubble. Two 30-40 ft tall monuments of excellent cut stone work were ruined. Ekra-built buildings also got damaged. Plank buildings of wooden framework and resting unattached on the ground remained intact.

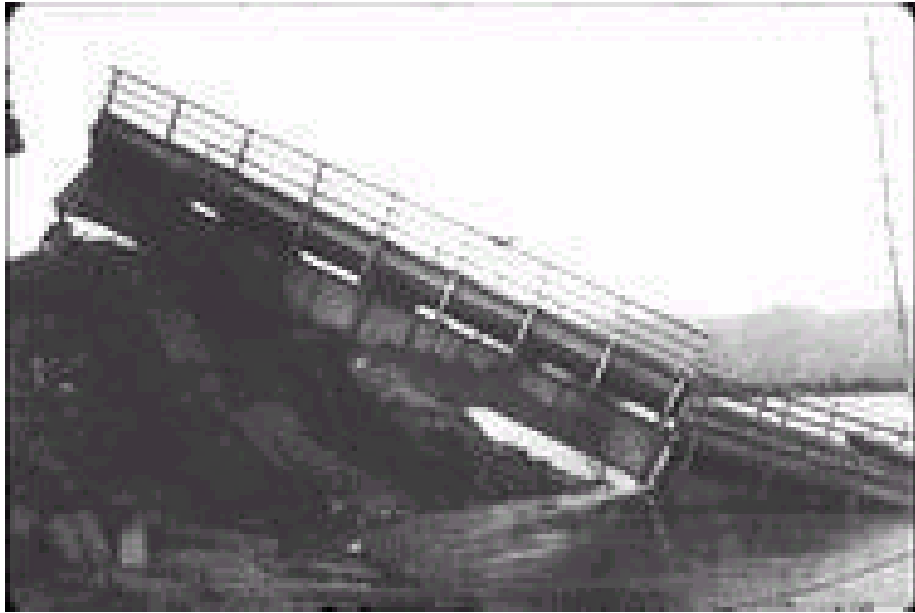
**North Lakhimpur, Assam Bridge on Ranganadi**
